NATIONAL PROGRAM FOR INSPECTION OF NON-FEDERAL DAMS
UPPER LAKE PHIPPS DAM. (U) CORPS OF ENGINEERS WALTHAM
MA NEW ENGLAND DIV JUL 80

COVE RIVER BASIN
WEST HAVEN, CONNECTICUT

UPPER LAKE PHIPPS
DAM NO.1 - CT 00109
DAM NO.2 - CT 00110

PHASE I INSPECTION REPORT
NATIONAL DAM INSPECTION PROGRAM

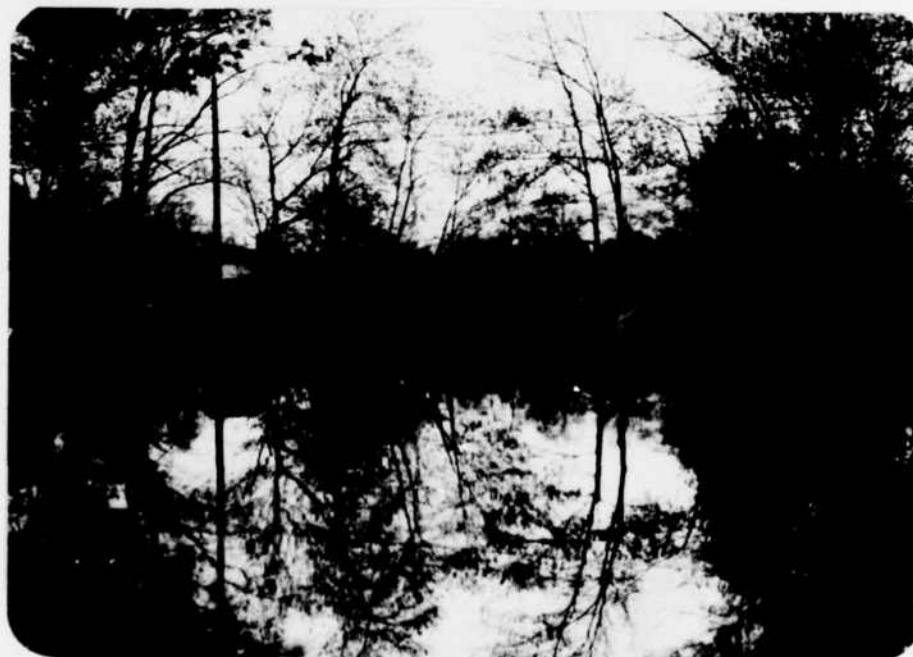
PHOTO NO. 12

At the causeway two 15-inch corrugated metal pipe culverts, Photo 12, discharge into a small pond which discharges to a natural stream through two additional 15-inch culverts.

CAUSEWAY AND CULVERTS
AT DAM NO. 3
